INDIVIDUAL PROPERTY/DISTRICT
MARYLAND HISTORICAL TRUST
INTERNAL NR-ELIGIBILITY REVIEW FORM

Property/District Name: Witter-Mercer Farm Survey Number: F:3-148

Project: I-270/US 15 Multimodal Study, Montgomery and Frederick Co. Agency: SHA

Witter-Mercer Farm

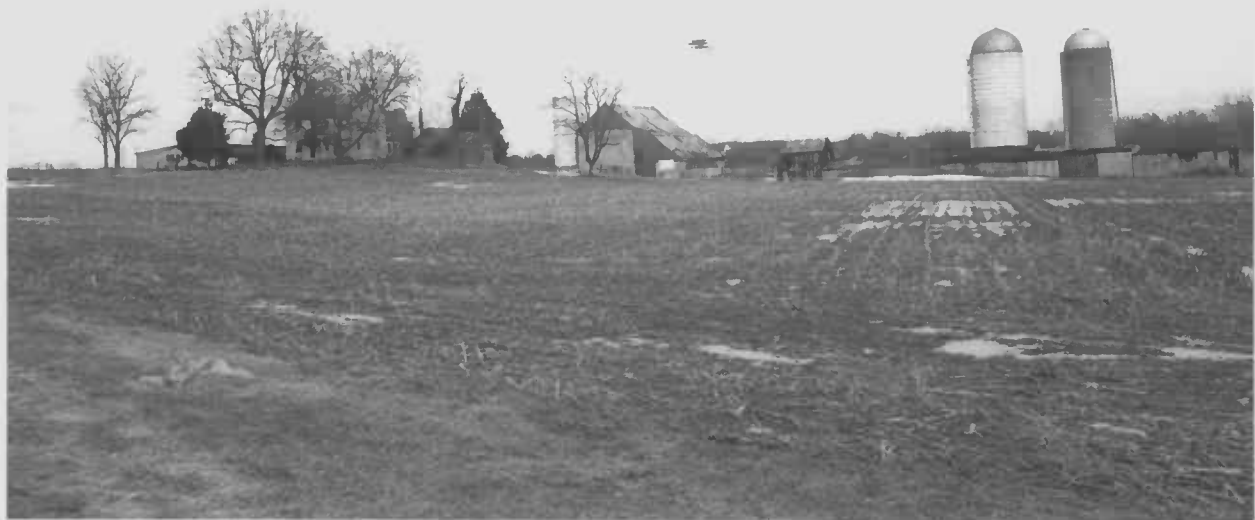
1/10

Overall view of farm looking
east

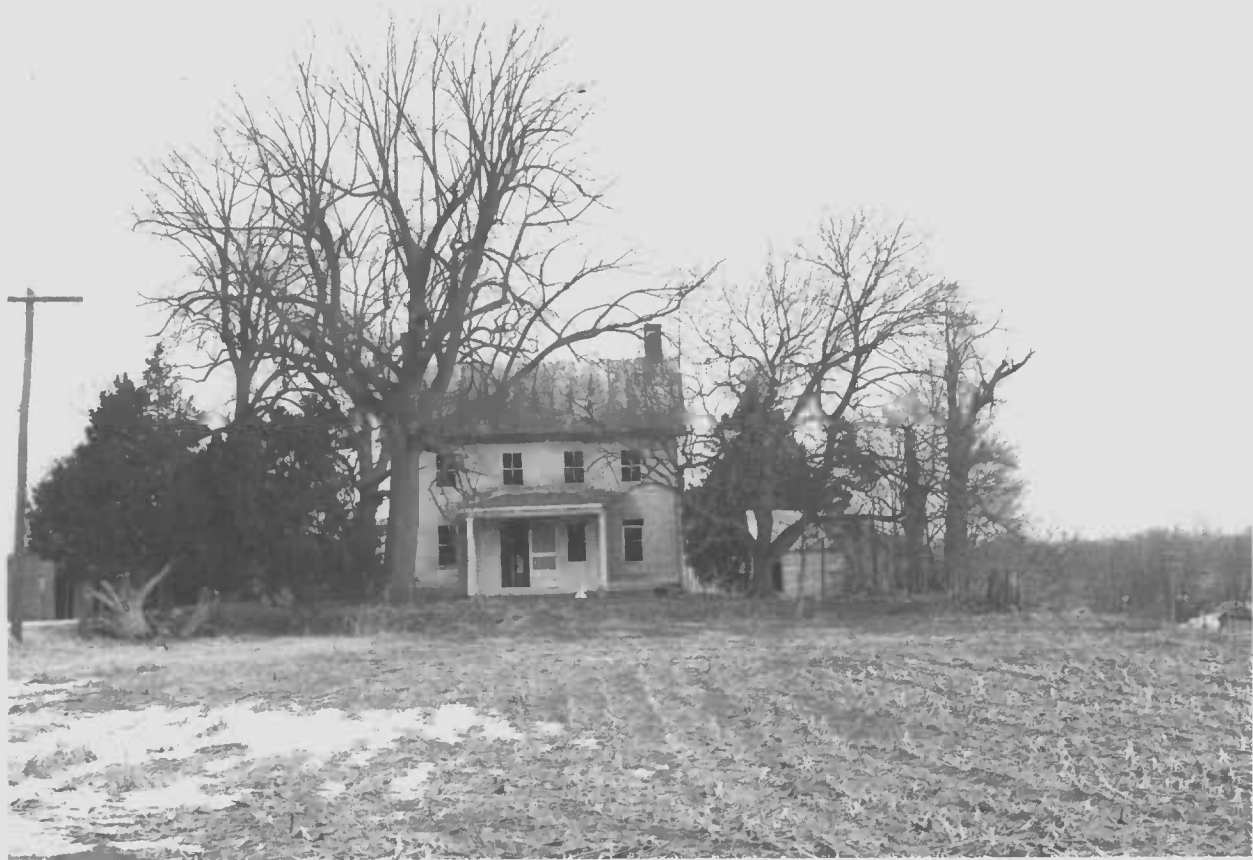
2/10

The main structure consists of two sections, roofed with standing seam metal, forming an L-shaped structure. The two-and-one half story gable-roofed front section faces US 15 on the west and contains the primary entrance. It is four bays wide on the principle (west) elevation with the doorway offset to the north. Sheathed with German siding, it features two-over-two lights, boxed cornice and return and cornerboards. Built on the rubblestone foundation, two chimneys, emerging at the peak are located inside of the north and south end walls. The interior of this main block, stripped of decorative trim, plaster and mantles, is characterized by two large rooms with stripped and closed brick fireplaces on each end wall. An open staircase is located in the northeast corner.

Dwelling (i)

West (Entrance) Facade

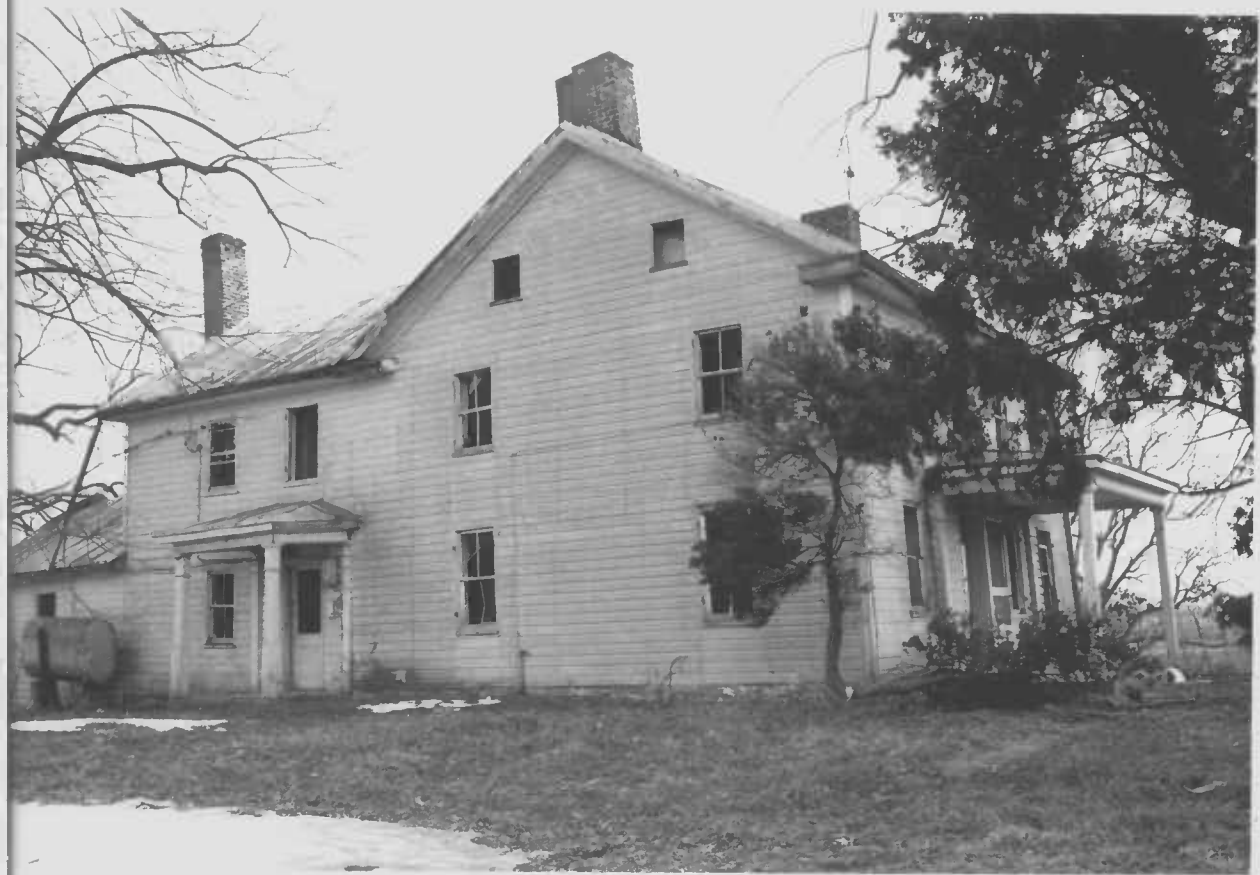
3/10

Dwelling

SW Corner

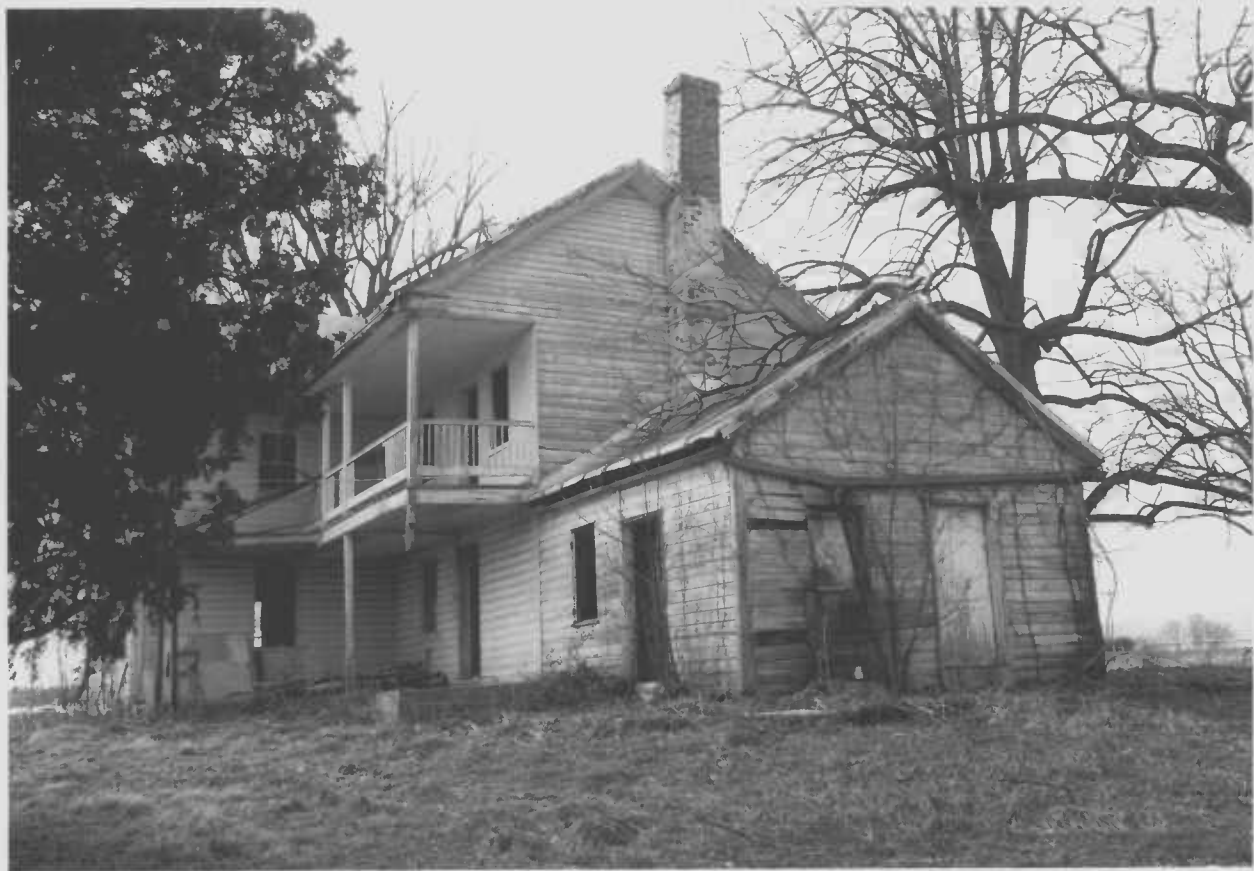
4/10

May at 1112 State Hwy Admin
Dwelling

SE Corner

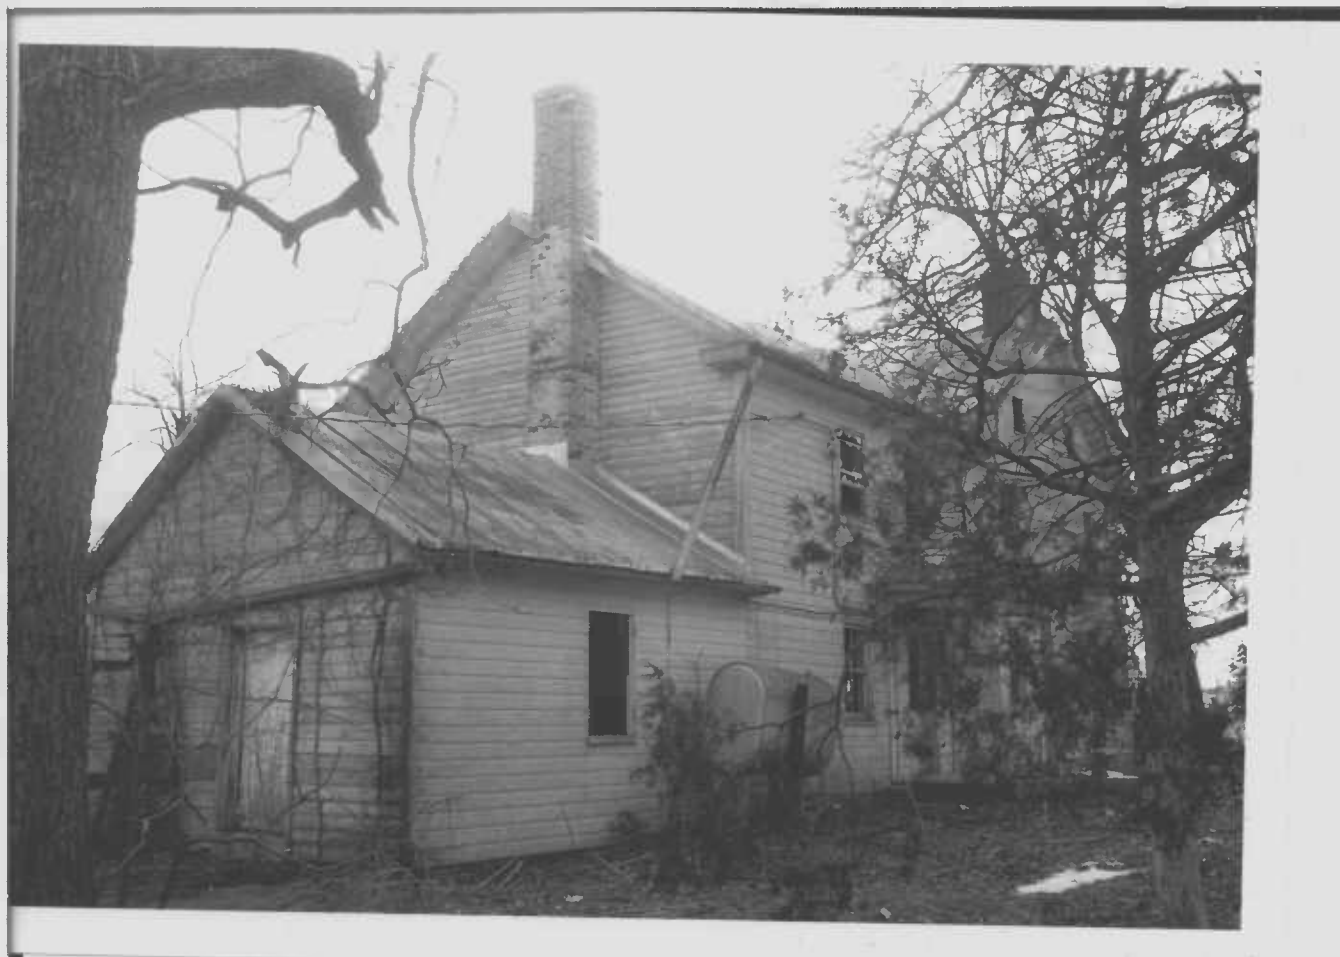
\$/10

Weg at MD. State Hwy Admin.
Dwelling

NE Corner

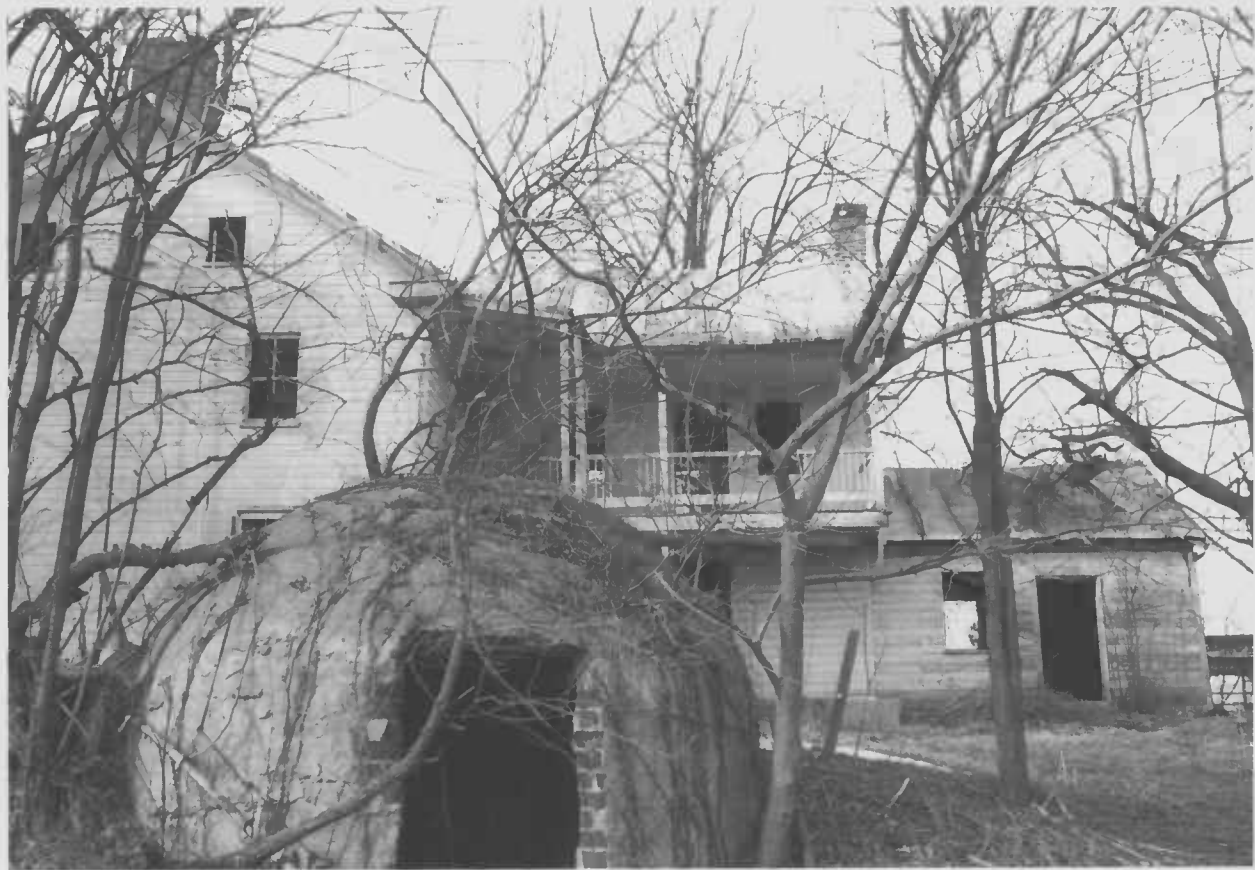
8/10

Attached to the rear (or east) wall of the kitchen wing is a one-story gable roofed summer kitchen with entrances on both the south and east sides. Constructed at a later date than the ell or the main block, it has a tall chimney centered on the west wall which rises the full height of the two-story abutting section just off center and north of its gable roof peak. The simple large fireplace constructed of stuccocoed brick is centered on the west wall. One of the descendants of the Mercers, Hilda Asherman, recounts that this room originally had a cistern which fed a handpump used for laundry. This feature does not appear to be extant.

Dwelling,

South elevation

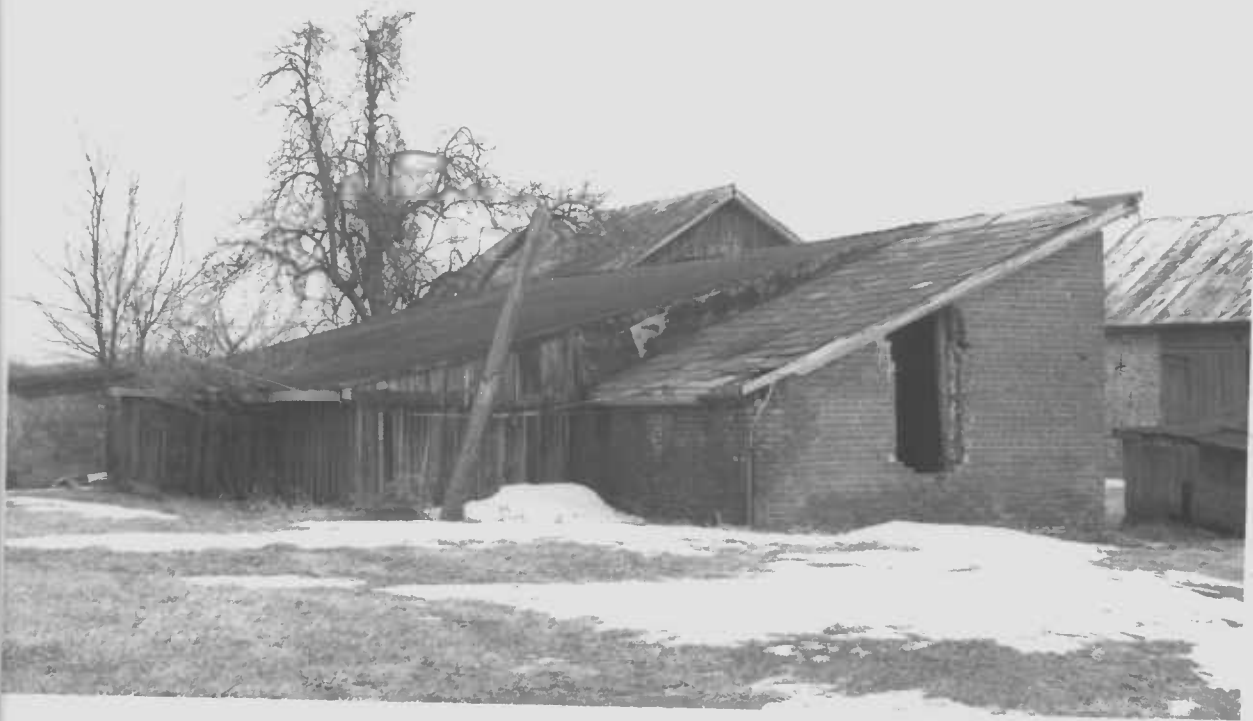
11/10

Oriented east-west and located off the northeast corner of the house, this long structure is composed of two sections: the westernmost is a brick, shed roofed brick feed shed with a deteriorated window in the west elevation and an entrance offset to the west in the south face. A decorative feature (a soldier brick course), set in a dogtooth pattern is centered on the south wall five courses below a deteriorated notched wooden cornice. The garden bond pattern characterizing the brick work has five rows of stretcher courses between the header rows.

Attached to its east wall is a deeper, board and batten machine shed with five openings on the south elevation.

Feedhouse / Shop

NW corner

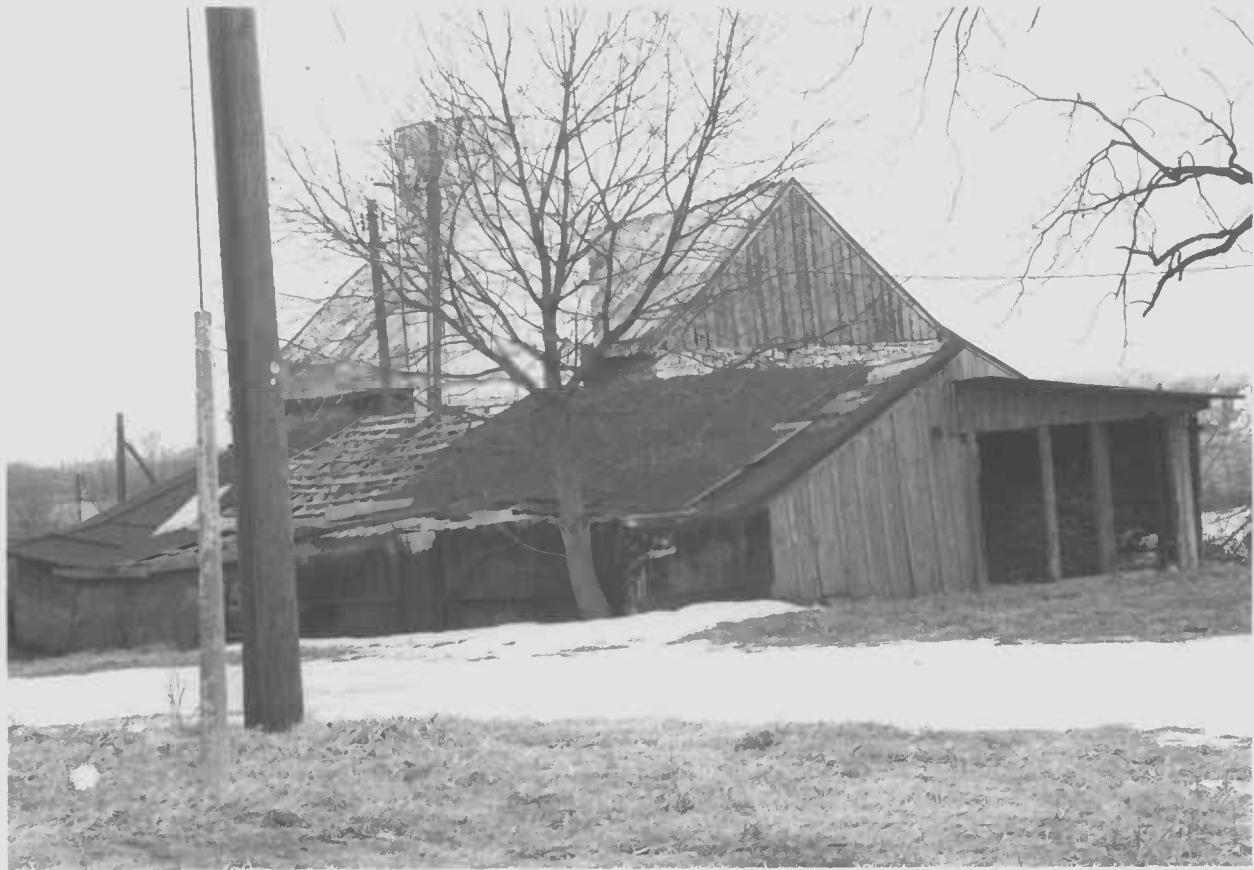
8/10

This large, one-story heavily deteriorated, largely board and batten structure is composed of two blocks whose shed rooves rise to two different levels creating a vertical clerestory area between them. There are large areas of metal sheathing and a partially destroyed corrugated metal roof.

Church house, new corner (foreground)
Bank barn in background

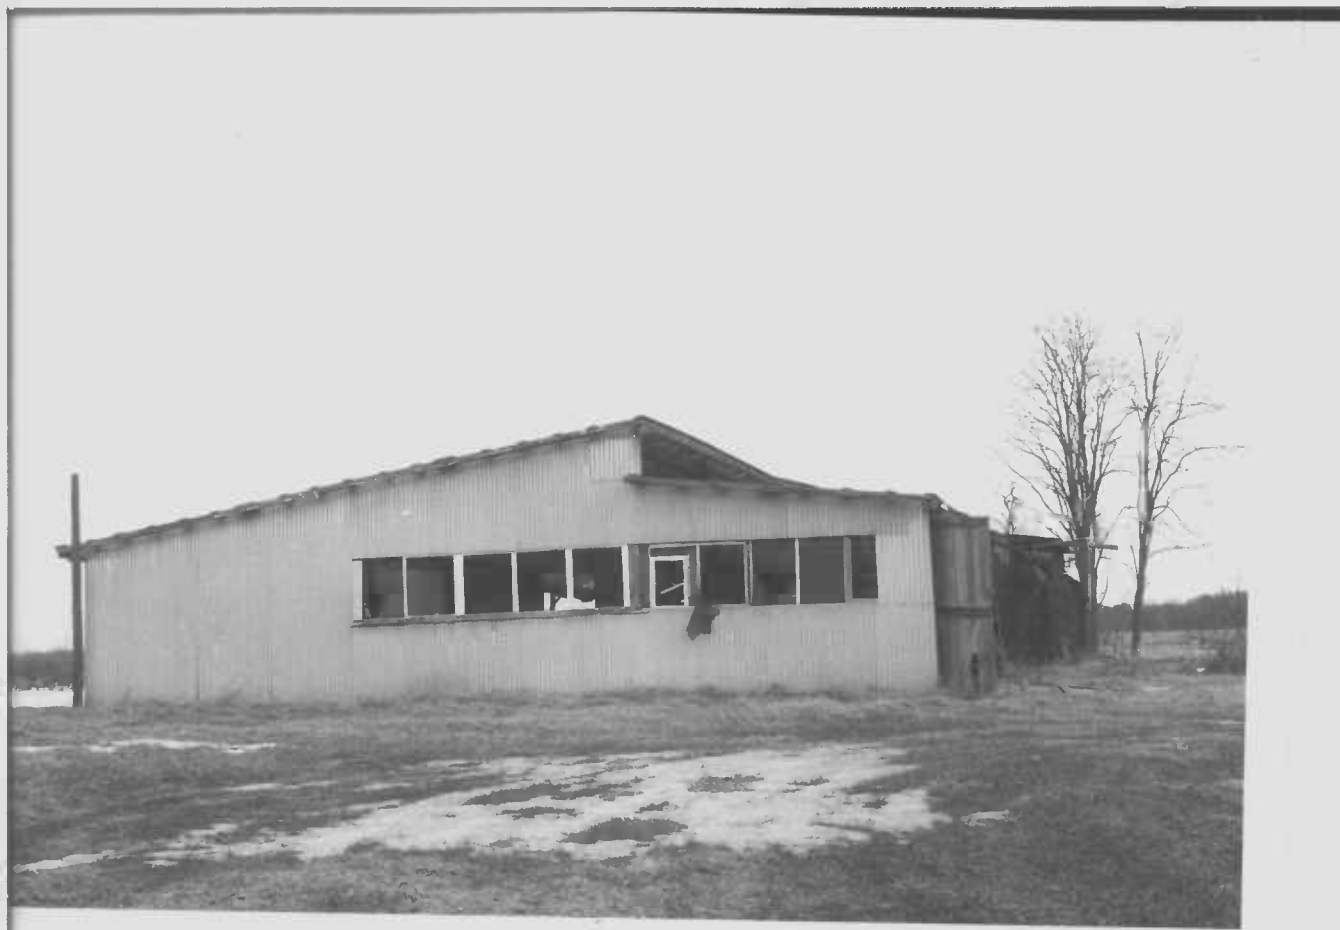
9110

Identified as a loafing shed by a descendent this building was constructed by Grayson Mercer, Jr. in 1950 after the older Mercers retired. It is a very large, one-story frame, metal sheathed structure composed of two blocks whose shed-rooves intersect to form a clerestory in the vertical strip between the two roof levels. Much of the corrugated metal and wood sheathing is missing. A horizontal band of windows is located at eye level on the west elevation (gable end).

Loofing, Shenandoah West entrance -

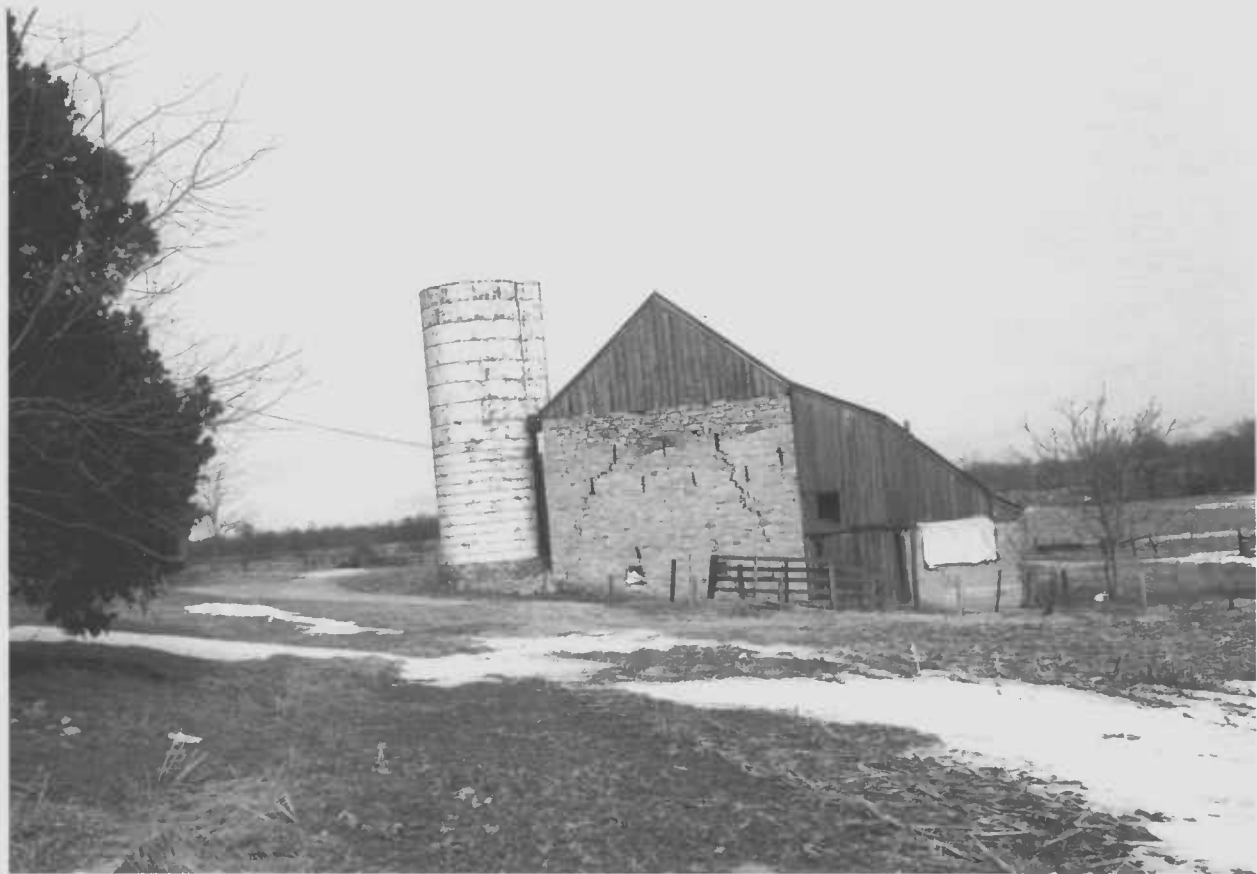
10/10

This large stone bank barn is built into a hill on the north where the earthen ramp gives access to the interior area through large wooden doors on strap hinges. The gable roof is corrugated metal oriented east-west, and the gable ends at the roof level are frame, resting on uncoursed rubble stone walls with vertical slits. The east wall has partially collapsed and the northeast corner has been re-constructed with concrete block. The barn has been extended on the south side with a large gambrel roofed addition, with walls constructed of concrete block and frame. A ca. 1950 silo is located immediately adjacent to the northwest corner.

Bank barn, S.W. Corner
